INFLUENCE OF THE SHAPE OF THE IMPACTOR ON RESIDUAL STRENGTH, SIZE AND NATURE OF DAMAGE TO CFRP

Abstract

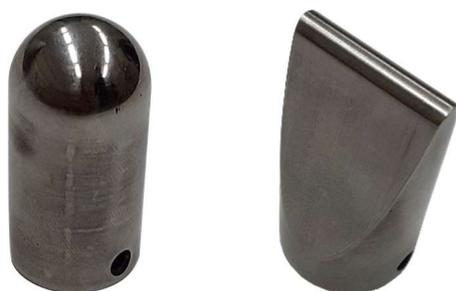
The impact resistance tests were conducted on an INSTRON CEAST 9340 drop tower. The samples were subjected to transverse impact loads of 10, 15, and 20 J energies. Two "impactors" were used, the first one with a spherical shape, 20 mm in diameter, and the second one wedge-shaped (V-shaped) with an opening angle of 30° and a striking edge radius of 3 mm (Fig. 1). A series of at least 3 samples was made for each energy and each impactor. The samples were placed on the stage without fixing.

Fig. 1. Shapes of 'impactors' used in the tests

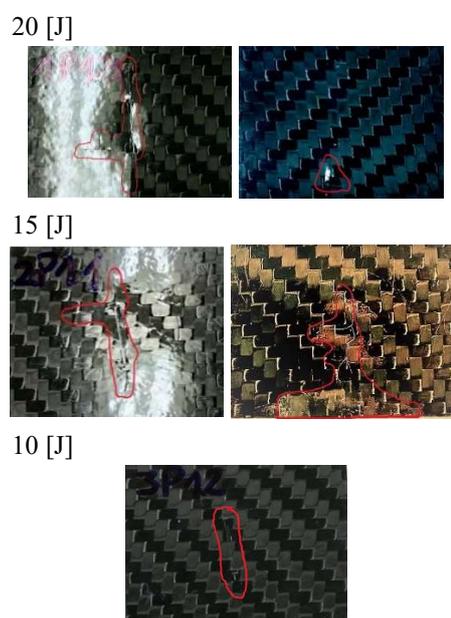
Fig. 2. Damage area of a sample impacted by a wedge-shaped impactor from the impacted side and opposite side

In the case of samples struck with a wedge 'impactor' on the impacted side, the composite was damaged with a shape reflecting that of the impactor (Fig. 2). Depending on the energy of the impact, there was cracking of the reinforcement along the fibres of the fabric with a different depth and area. For an impact energy of 10 [J], the damage on the impacted side is tiny, with an average area of approximately 150 mm². Furthermore, no damage to the laminate was observed on the side opposite to the impacted side.

which was assessed. The damage areas of the laminate on the impacted side and the opposite side were used as a comparative parameter. The selected and representative images along with marked areas of damage, after an impact, with different energies and impactors are presented in Figure 2 and Figure 3.

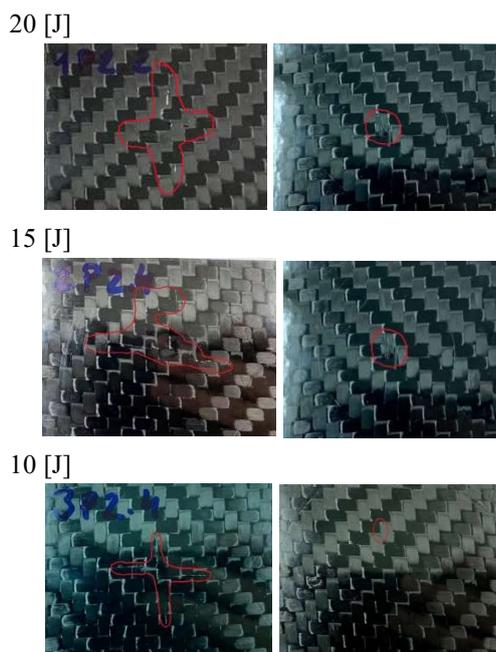
The surface of the samples impacted by the spherical impactor caused damage in the form of an indentation, which initiated cracks in the horizontal and vertical cross-shaped reinforcement fabric (Fig. 3). Similarly to the previous 'impactor', the area of damage depends on the energy of the impact. Damage was observed on the surface opposite to the impacted area for each energy. For the highest energy value (20 [J]) there is also a clear perforation of the laminate.

Fig. 3. Damage area of a sample struck by a spherical shaped impactor from the impacted side and opposite side.

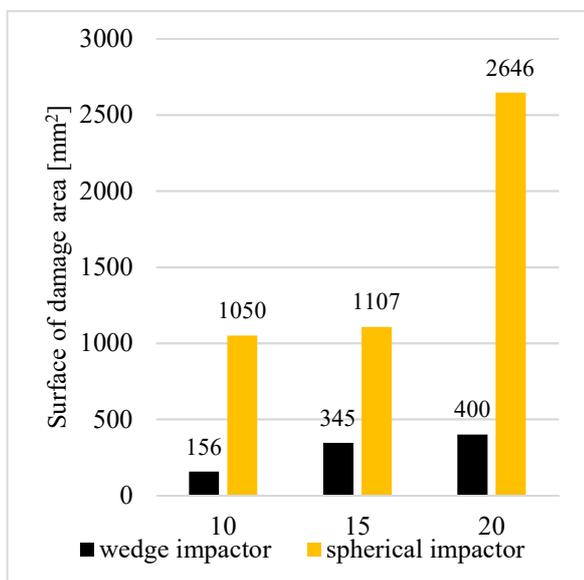
Fig. 4. Damage area on the impacted side

The damage area of the tested composite is always larger for a spherical 'impactor'. The damage to the samples is approximately 6.5 times greater with a spherical 'impactor' on the struck surface (Fig. 4). However, on the surface opposite to the impacted surface (Fig. 5), the damage is comparable and only approximately 10 % larger for the spherical impactor. On both the impacted and counter-impacted surfaces,

the difference in damage size for both impactors depends on the impact energy. The largest damage area was recognized after impact with 20 [J] energy, but especially in the counter-impacted surface difference for wedge impactor is about 30% and about 80% for spherical impactor.

When comparing the damage areas on the impacted side (Fig. 4) and on the opposite surface (Fig. 5), some regularities can be noticed in the aspect of the shape of the "impactor."

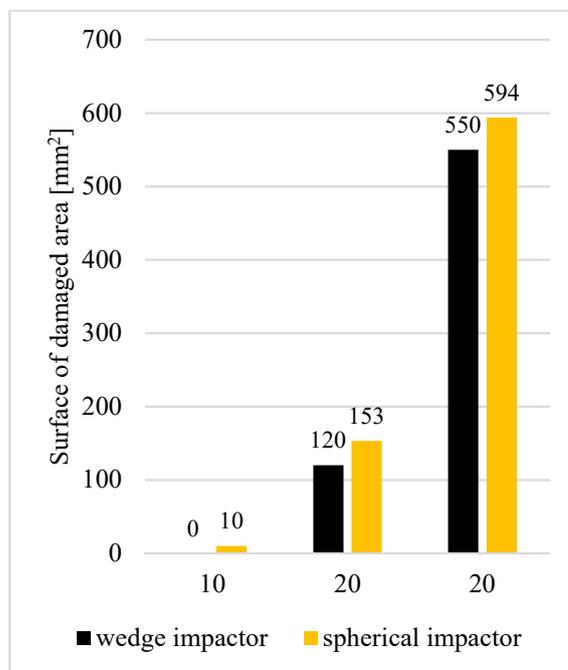
Fig. 5. Surface area of damage on the opposite side from the impacted side

The damage area of the tested composite is always larger for the spherical 'impactor'. However, on the surface opposite to the impacted surface damage, the damage is comparable and is only approximately 10% larger for the spherical impactor.

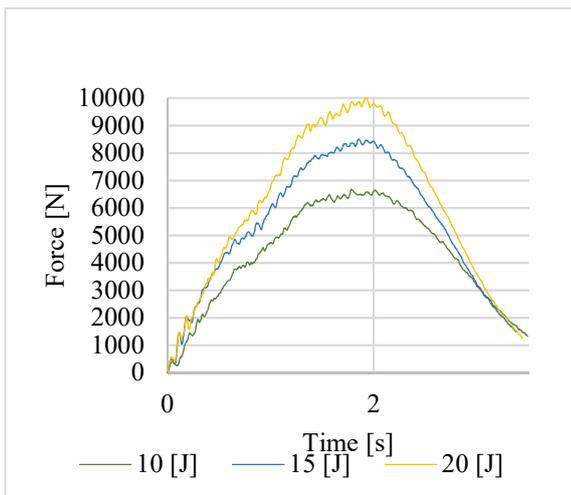
By comparing the characteristics of force variation over time, it is possible to see significant differences in the behaviour of the examined material when impacted with different 'hammers'. In the case of a 'spherical impactor', the change in impact energy does not affect the way the composite responds to the impact; also the shape of the curve indicates its elastic nature.

Fig. 6. Force variation during in impact with a spherical "impactor"

In addition, the response (contact) time of the composite is identical for all impact energies. In the case of a 'wedge hammer', the nature of the curve

Detailed comparisons of the force variation curves (Fig. 6, Fig. 7) over time and of the force variation with respect to deformation makes it possible to conclude that the "wedge impactor" caused internal damage to the laminate and that its "depth along the thickness of the examined material depends on the impact energy.

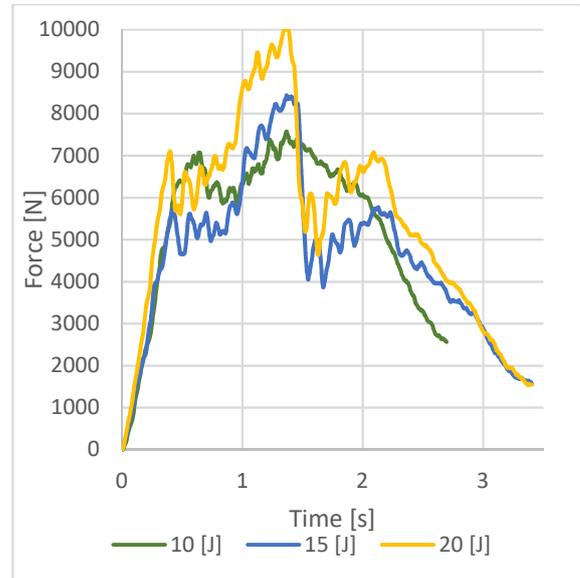
(Force-Time) (Fig. 7) indicates permanent deformation under impact loading and damage within the composite.

Fig. 7. Force variation curves during an impact with a wedge-shaped impactor

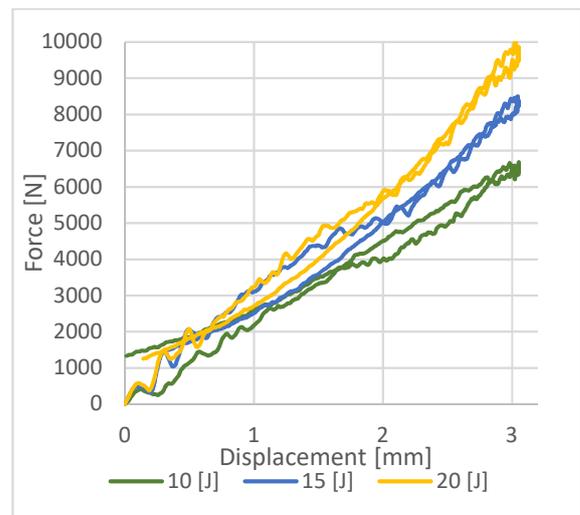
Fig. 8. Force-deformation curves for the impact of a spherical "impactor"

The characteristics of the change in force versus deformation (Fig. 8, Fig. 9) allow the energy absorbed by the laminate to be estimated (area inside the curve-area under the force-deflection curve).

The slope of the curve provides an estimate of the stiffness of the composite and the shape of the curve indicates the nature of the damage to the composite. In the case of tests carried out with two different shape impactors, there was no complete perforation of the composite, as evidenced by the closed loop of the curve and the return of the force with respect to deformation at the initial value. However, there is clearly a change in the nature of the composite's response to an impact depending on the shape of the 'impactor'. Also, the value of the absorbed energy depends on the type of used 'impactor'.

Based on the obtained parameters, it can be concluded that the force transmitted by the test material mainly depends on the value of the impact energy and is highest for the highest impact energies. It only slightly depends on the shape of the "impactor". The differences in peak force values (Peak Force) are only about 10 % and increase with the impact energy. In order to analyse the puncture resistance in detail, a comparison was also made of the force variation (Fig. 6, Fig. 7) over time and the force variation with respect to deformation (Fig. 8, Fig. 9).

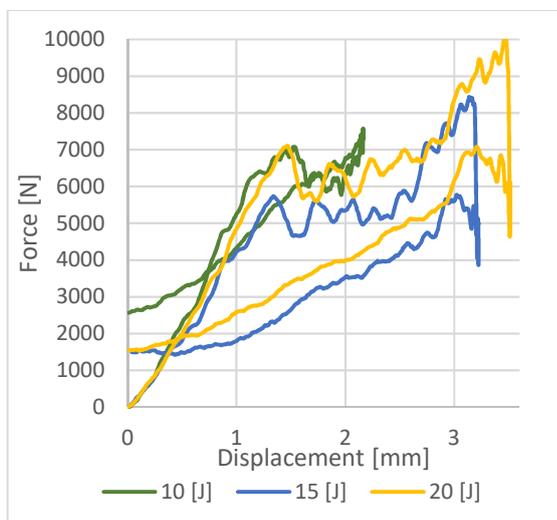
Fig. 9. Force vs. deformation curves for a wedge-shaped impactor

Furthermore, in the case of the 'wedge impactor', the amount of absorbed energy depends on the value of the impact energy, as indicated by the changes in the shape of the force-deformation characteristics (Fig. 9).

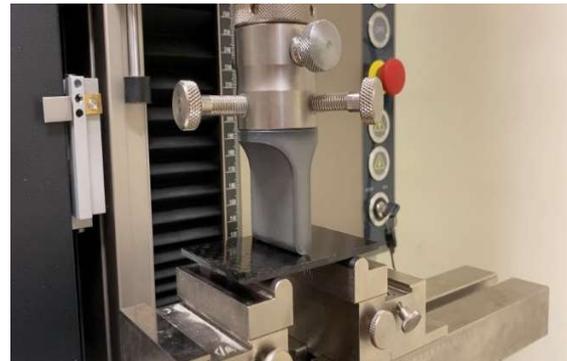
The test was conducted in a three-point bending scheme on a ZWICK/ROELL Z5 testing machine in accordance with PN EN ISO 178, at the support span of $L=46$ mm (Fig. 10).

Fig. 10. Bending flexural strength test

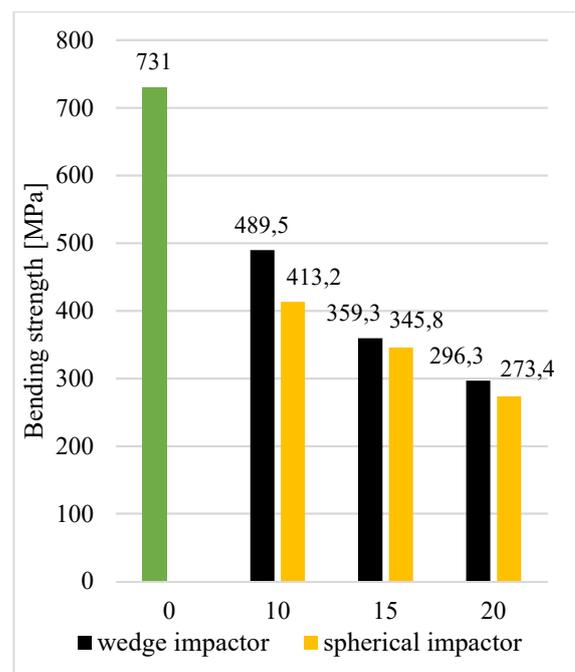
The changes in the bending strength values are mainly dependent on the impact energy and, compared to the control samples (not subjected to an impact), there was a decrease of approximately 40% for an impact energy of 10 [J], 50% for an impact energy of 15 [J] and 60% for an impact energy of 20 [J].

Fig. 11. Bending strength σ_{FM} [MPa]

The obtained results were related to the control (non-impacted) samples and the results are presented in Figures 11, 12, 13.

The "wedge impactor" resulted in a greater decrease in bending strength. However, the variation in its value mainly depends on the impact energy; the differences in the aspect of the 'impactor' shape decrease with an increasing impact energy, amounting to approximately 10% for the impact energy 10 [J], approximately 3% for the impact energy 15 and 20 [J].

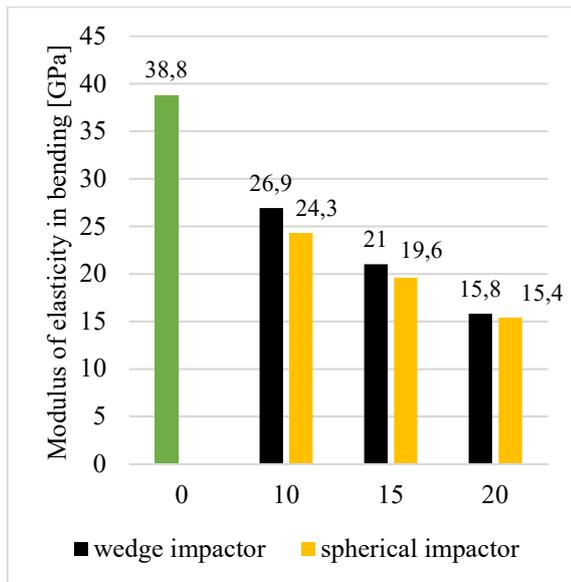
Fig. 12. Modulus of elasticity in bending E_r [GPa]

The differences with regard to the 'impactor' shape are minimal and decrease along with an increase in an impact energy: approximately 5% for an impact energy of 10 [J], approximately 3% for an impact energy of 15 [J] and 1% for an impact energy of 20 [J].
